# **INSPECTION AND ANALYSIS OF FAILED TRANSMISSIONS**

**INTERIM REPORT  
TFLRF No. 399**

**U.S. Army TARDEC Fuels and Lubricants Research Facility  
Southwest Research Institute® (SwRI®)  
San Antonio, TX**

for  
**U.S. Army TARDEC  
Force Projection Technologies  
Warren, Michigan**

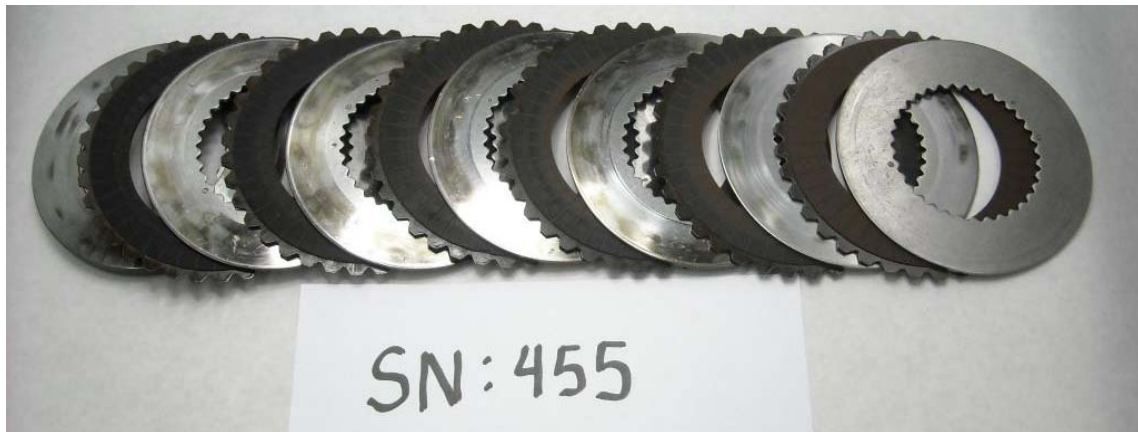
**Figure 1 - SN455 C1 Friction Disks and Reaction Plates**

Figure 1 below shows SN455 C1 clutch pack damage. Steel reaction plates were warped and contained hot spots on the reaction surface. Friction disks were burnt and darkened, but remained intact without any chipping or flaking of the friction surface. C1 clutch pack clearance was found to be minimal due to the warped steel plates.

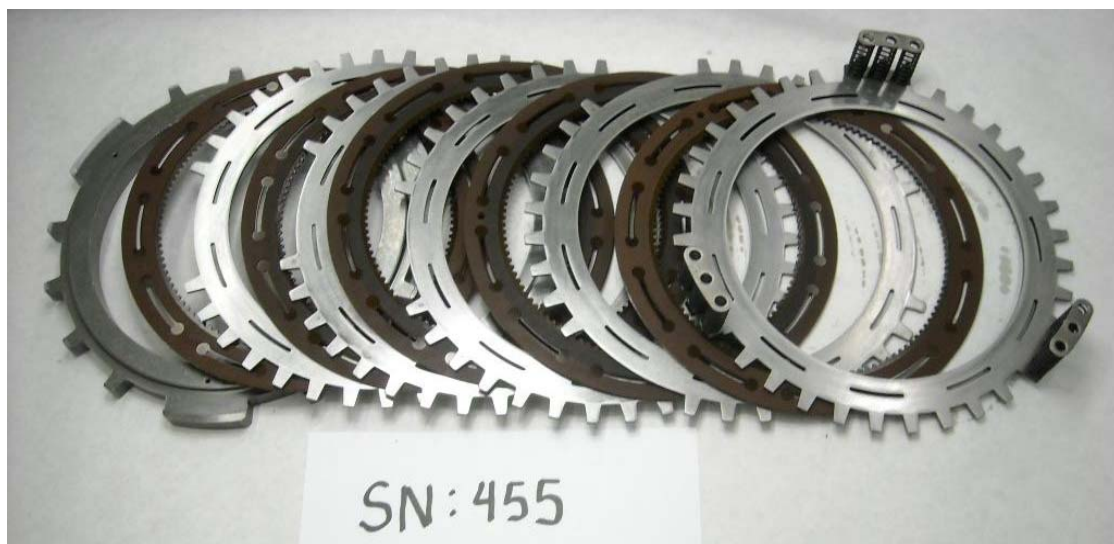
**Figure 2 - SN455 C4 Friction Disks and Reaction Plates**

Figure 2 below shows SN455 C4 clutch pack damage. Overall condition was good with some mild darkening of the inner radius of the friction disks. Component rating information on clutch packs and planetary gear sets, along with pictures of all clutch packs for SN455 can be found in Appendix A.

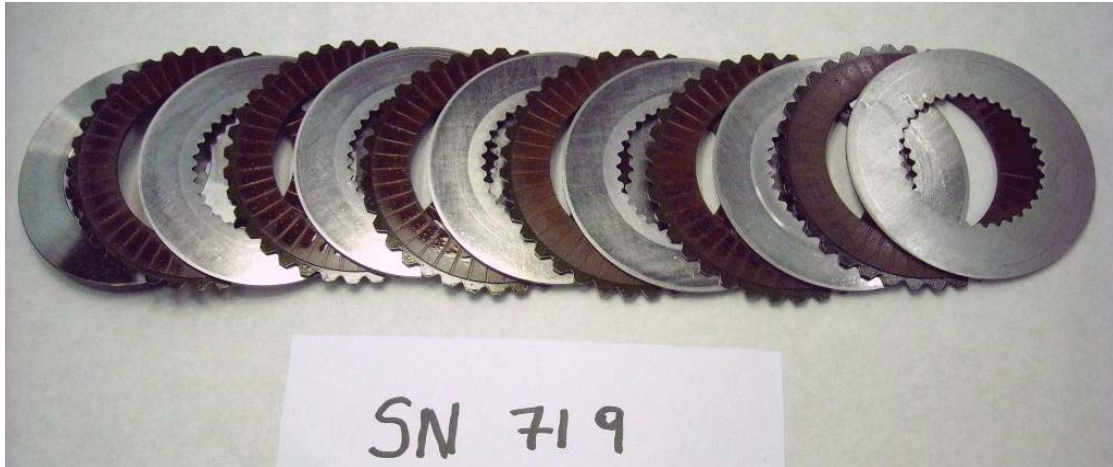
**Figure 3 - SN719 C1 Friction Disks and Reaction Plates**

Figure 3 below shows SN719 C1 clutch pack. Overall clutch condition was excellent with minimal to no darkening of the friction disks.

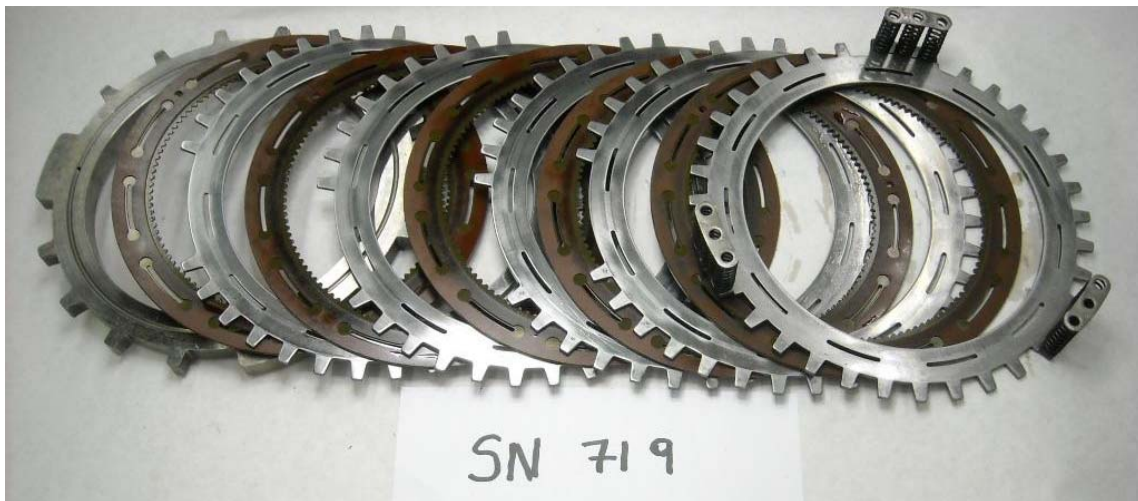
**Figure 4 – SN719 C4 Friction Disks and Reaction Plates**

Figure 4 below shows SN719 C4 clutch pack. Overall condition was found to be slightly better than SN455, but still contained darkening of the friction disk inner radius. Component rating information on clutch packs and planetary gear sets, along with pictures of all clutch packs for SN719 can be found in Appendix B.

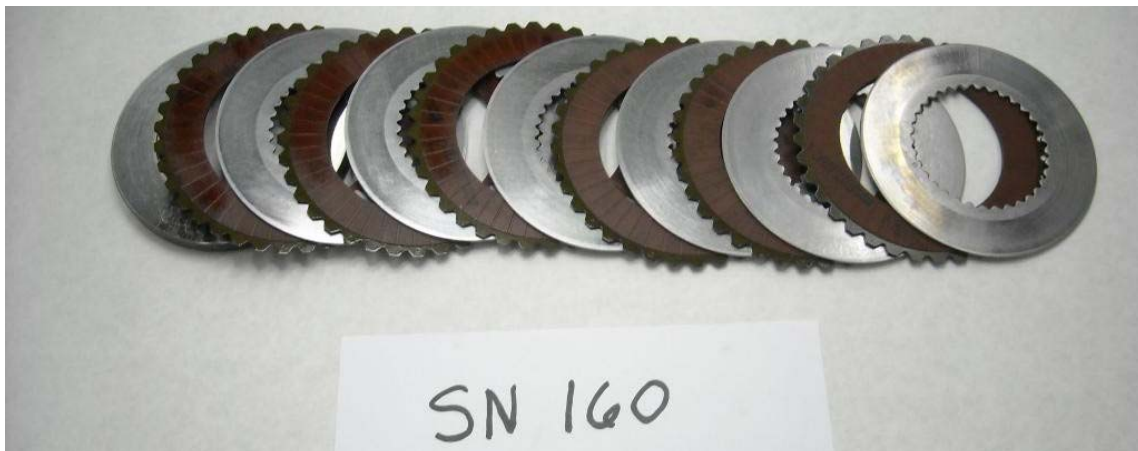
**Figure 5 - SN160 C1 Friction Disks and Reaction Plates**

Figure 5 below show SN160 C1 clutch pack. Condition of all clutches found to be in excellent condition. Component rating information on clutch packs and planetary gear sets, along with pictures of all clutch packs for SN160 can be found in Appendix C

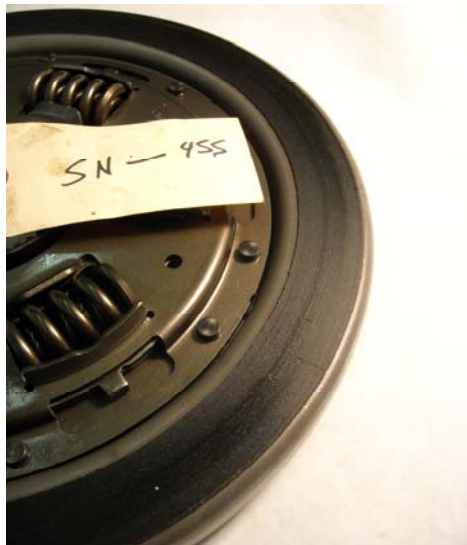
**Figure 8 - SN455 Lockup Friction Plate**

As to be expected from previous findings, the lockup clutch friction plate and reaction surface both showed signs of exposure to high temperatures. Although darkened, the friction disk showed no signs of chipping or flaking on the friction material as seen below in Figure 8.

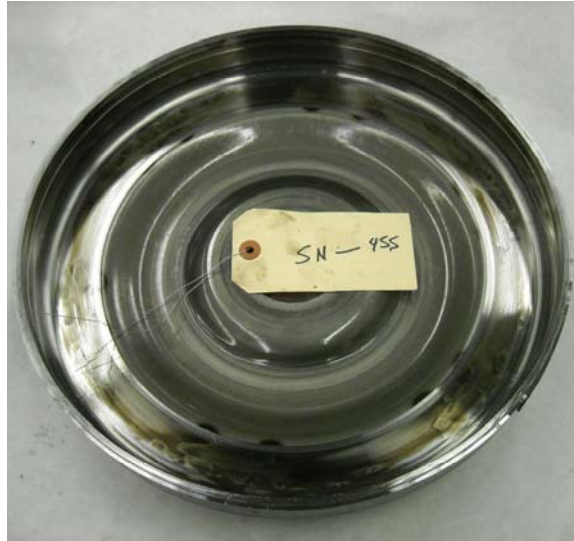
**Figure 9 - SN455 Lockup Reaction Plate**

The steel reaction plate showed some mild signs of damage with minor polishing and various hot spots as shown in Figure 9.

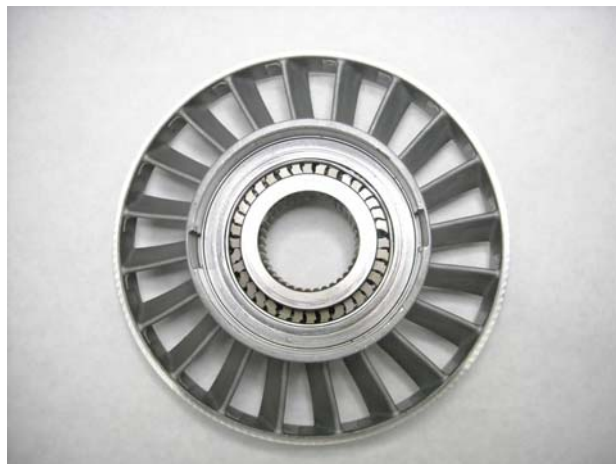
**Figure 10 - SN455 Stator Clutch Assembly**

It was determined that a damaged or malfunctioning stator is the likely cause of the transmission failure. Stator operation is discussed further in the Operational Effects of Failure section. Upon disassembly of the stator, the retainer plate was removed also revealing a seizure of the one-way clutch assembly as shown in Figure 10.

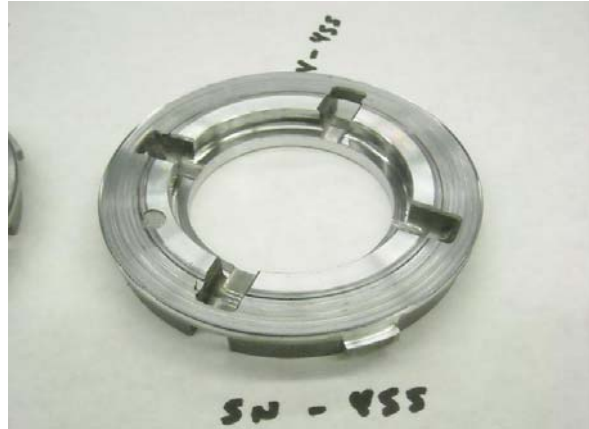
**Figure 11 - SN455 Retainer Plate Wear**

Ordinarily there is no relative motion between the retainer plate and outer area of the one-way clutch, as the one-way clutch assembly is a press fit within the stator wheel. It was

found that in SN455 there has been considerable relative motion between the two surfaces, evident by scarring and wear of the retainer plate and outer one-way clutch assembly. Retainer plate wear is shown below in Figure 11.

This relative motion between each surface is likely caused by expansion of the outer stator turbine wheel due to excessive heat, allowing the entire one-way clutch assembly to rotate within the stator wheel. It is possible that the one-way clutch itself was functioning until wear material entered the assembly from the reaction plate causing the doglegs to gall and seize.

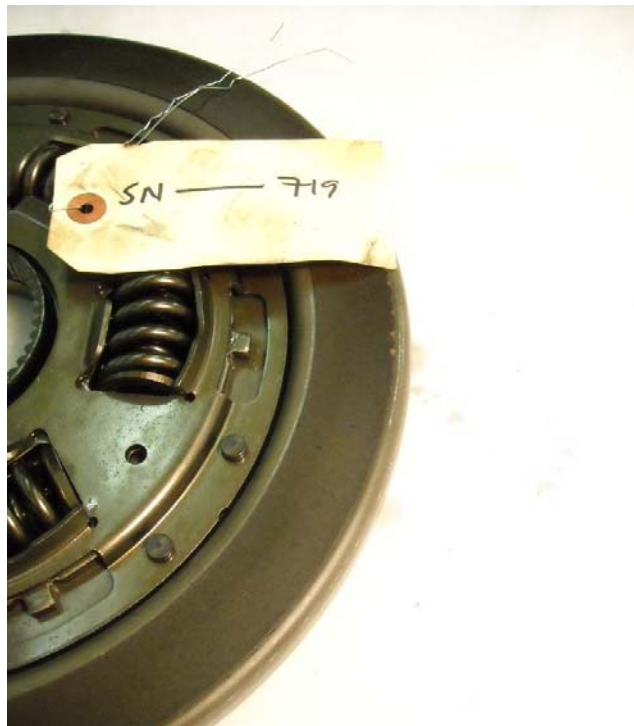
**Figure 12 - SN719 Lockup Friction Plate**

As seen below in Figure 12, SN719 lockup clutch friction plate was found to be in good condition with only some mild darkening. It was noted that a few small chips in the friction material surface was found along the outer edge, but it is unknown if this occurred from use or during disassembly and handling.

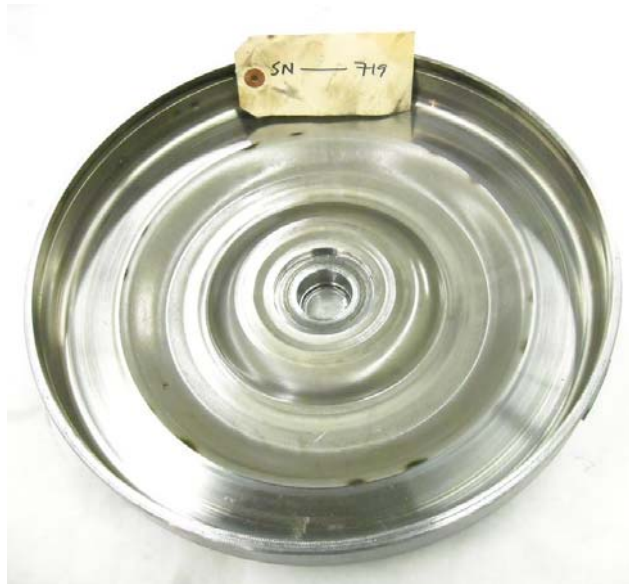
**Figure 13 - SN719 Lockup Reaction Plate**

The lockup clutch reaction plate was found to be in good condition with no evidence of polishing or hot spots as shown below in Figure 13.

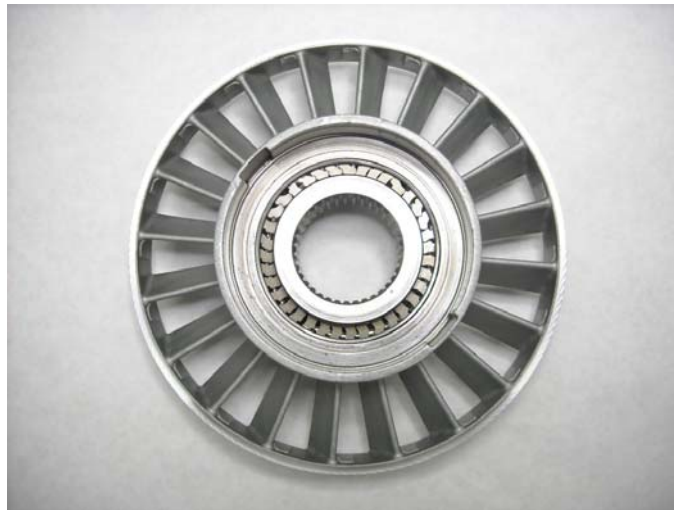
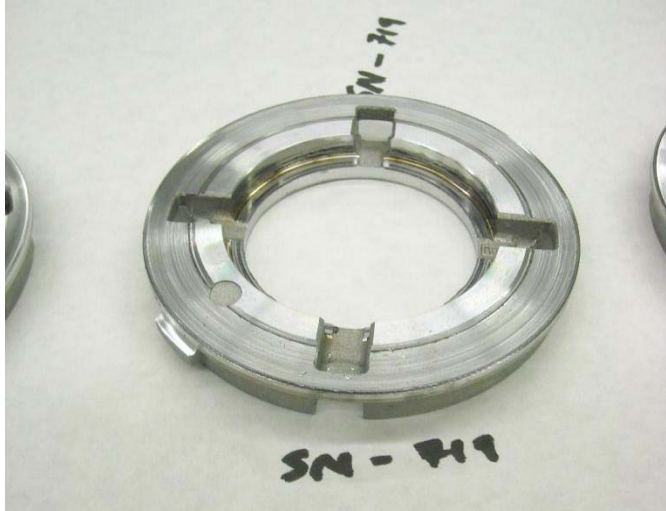
Consistent with SN455, the failure in transmission SN719 was attributable to a damaged or malfunctioning stator assembly. As shown below in Figure 14 and Figure 15, like SN455, the retainer plate and one-way clutch assembly has moved relative to one another causing severe wear on both surfaces. Again, a complete seizure of the one-way clutch was found, likely due to galled doglegs in the assembly.

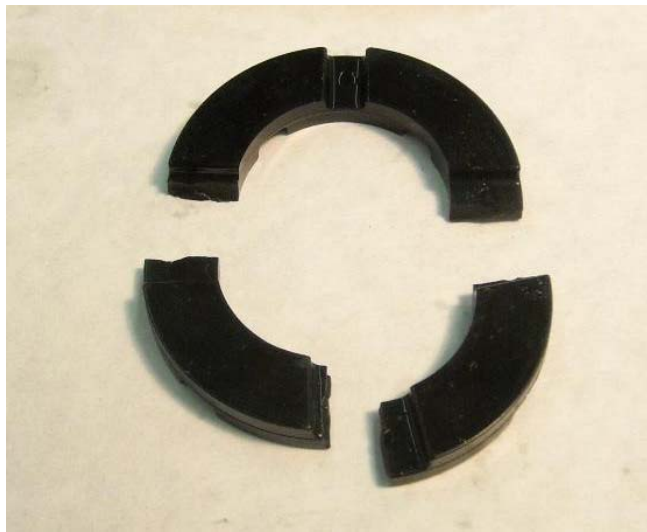
**Figure 16 - SN719 Turbine Housing Support Bushing/Thrust Washer**

In addition to the failed stator, SN719 was also found to have a broken turbine housing support bushing/thrust washer as shown below in Figure 16. It is likely that this was caused by other problems (i.e. lockup clutch chatter, heat, etc), and is a result of the overall failure and not a cause.

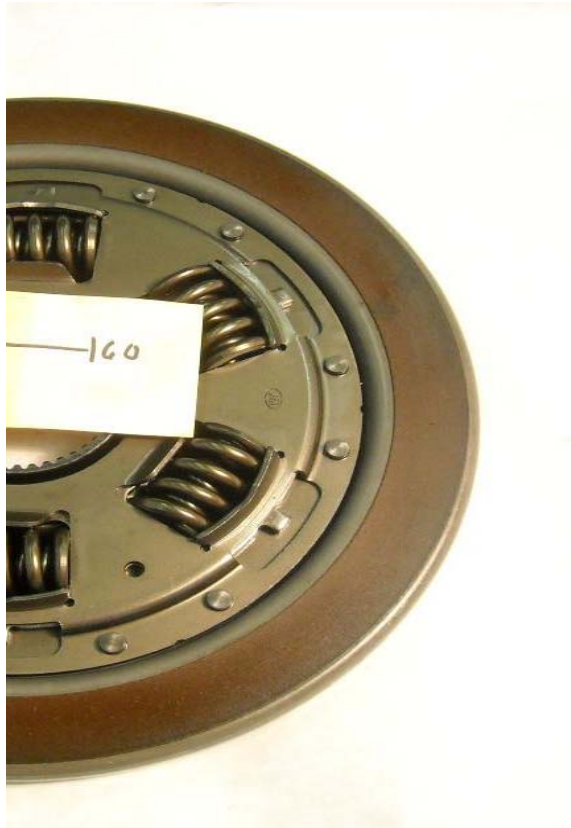
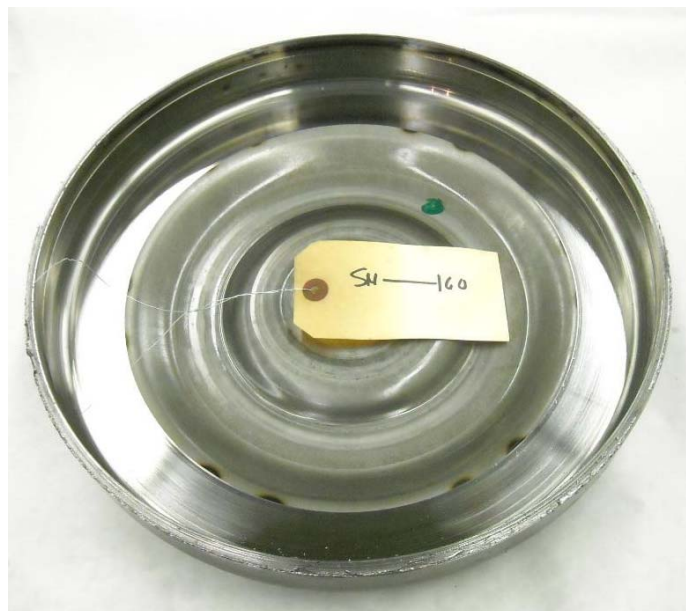
SN160 lockup clutch assembly was found to be in like new condition, with little to no darkening of the friction material, and no polishing or hot spots present on the reaction plate. SN160's lockup friction disk and reaction plate can be seen below in Figure 17 and Figure 18 respectively.

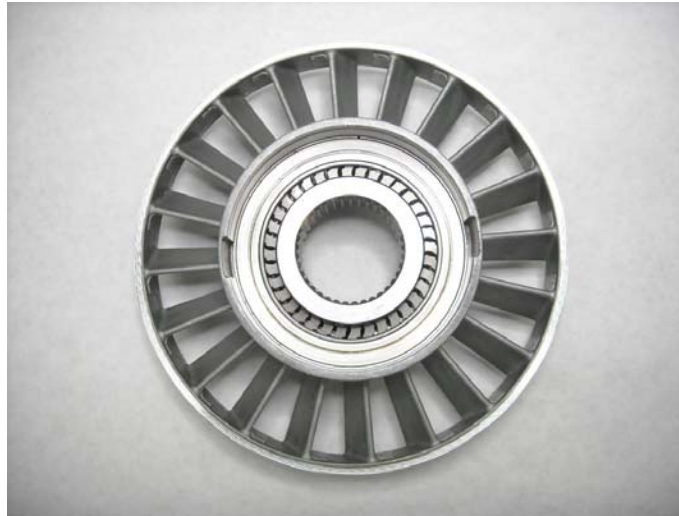
**Figure 19 - SN160 Stator Clutch Assembly**

Like SN455 and SN719, the failure is attributable to a malfunctioned stator assembly on SN160. However, differences existed between the severity of wear found, and overall condition when compared with the two previous units. Again there was evidence of relative motion between the retainer plate and outer housing of the one-way clutch, but not to the severity of the other units. Like before, it is likely that high temperature caused the expansion of the stator turbine wheel and allowed the one-way clutch assembly to free spin within the stator turbine wheel. From the damage found, it appears as if this unit was removed from service more quickly, as the wear on the retainer plate is minimal. Different from the previous units, the one-way clutch was found to still be operable and did not show signs of premature wear. Figure 19 below shows SN160 stator and one-way clutch assembly.

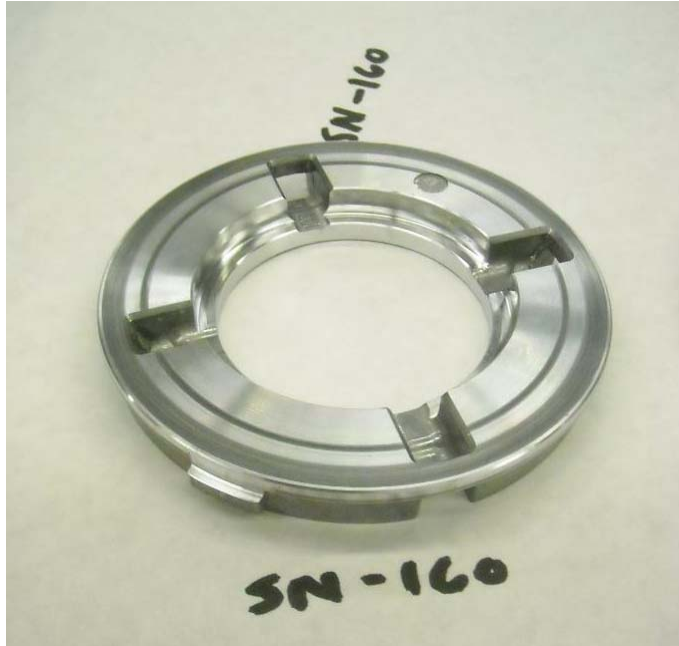
**Figure 20 - SN160 Retainer Plate Wear**

Similar to the previous retainer plates, the wear patterns on SN160's retainer plate were consistent and showed similar high and low wear areas on its surface. SN160's retainer plate can be seen below in Figure 20.

It is likely that with continued use, SN160's retainer plate would continue to wear against the one-way clutch causing wear metals to enter the one-way clutch assembly resulting in an eventual seizure consistent with SN455 and SN719.

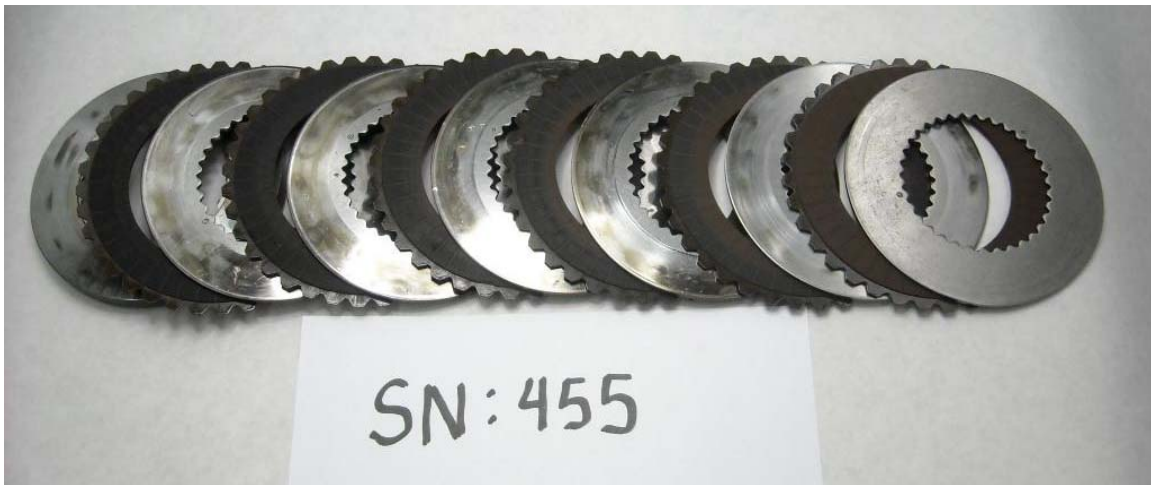
**SN455 C1 Friction Disk and Reaction Plates**

Each clutch pack (friction disk and reaction plates) is shown below in sequential order from C1 to C5. SN455 experienced the most clutch damage due to high fluid temperatures. C1 clutch pack had to be forcibly removed from the transmission due to warped reaction plates.
